RICHELIEU RIVER BASIN
HARDWICK, VERMONT

HARDWICK LAKE DAM VT 00186

PHASE I INSPECTION REPORT NATIONAL DAM INSPECTION PROGRAM

OCT., 1980

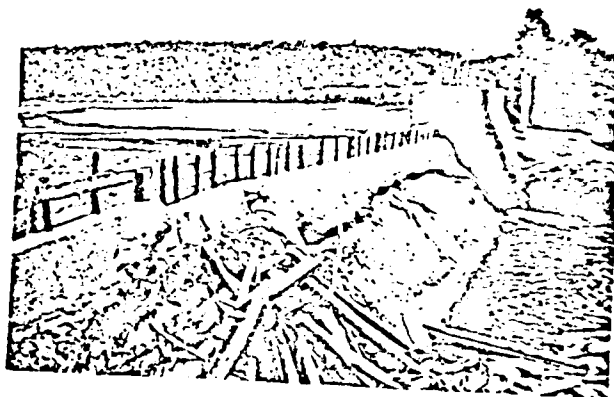
Fig. 1. - Eroded condition of downstream face,
main spillway section of Hardwick Lake Dam

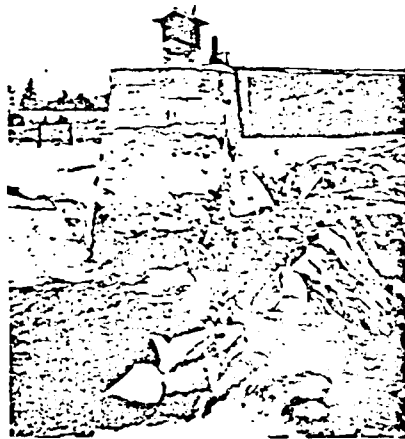
Fig. 3. - Eroded condition of the sluiceway pier,
